# GRACE MINE TAILINGS DAM

NDI-PA 00715  
PA DER 6-445

PHASE I INSPECTION REPORT  
NATIONAL DAM INSPECTION PROGRAM

Name of Dam: Grace Mine Tailings Dam - ID # PA 00715  
State Located: Pennsylvania  
County Located: Berks  
Stream: Tributary to Hay Creek  
Coordinates: Latitude 40° 11.3' Longitude 75° 52.1'  
Date of Inspection: May 15, 1979

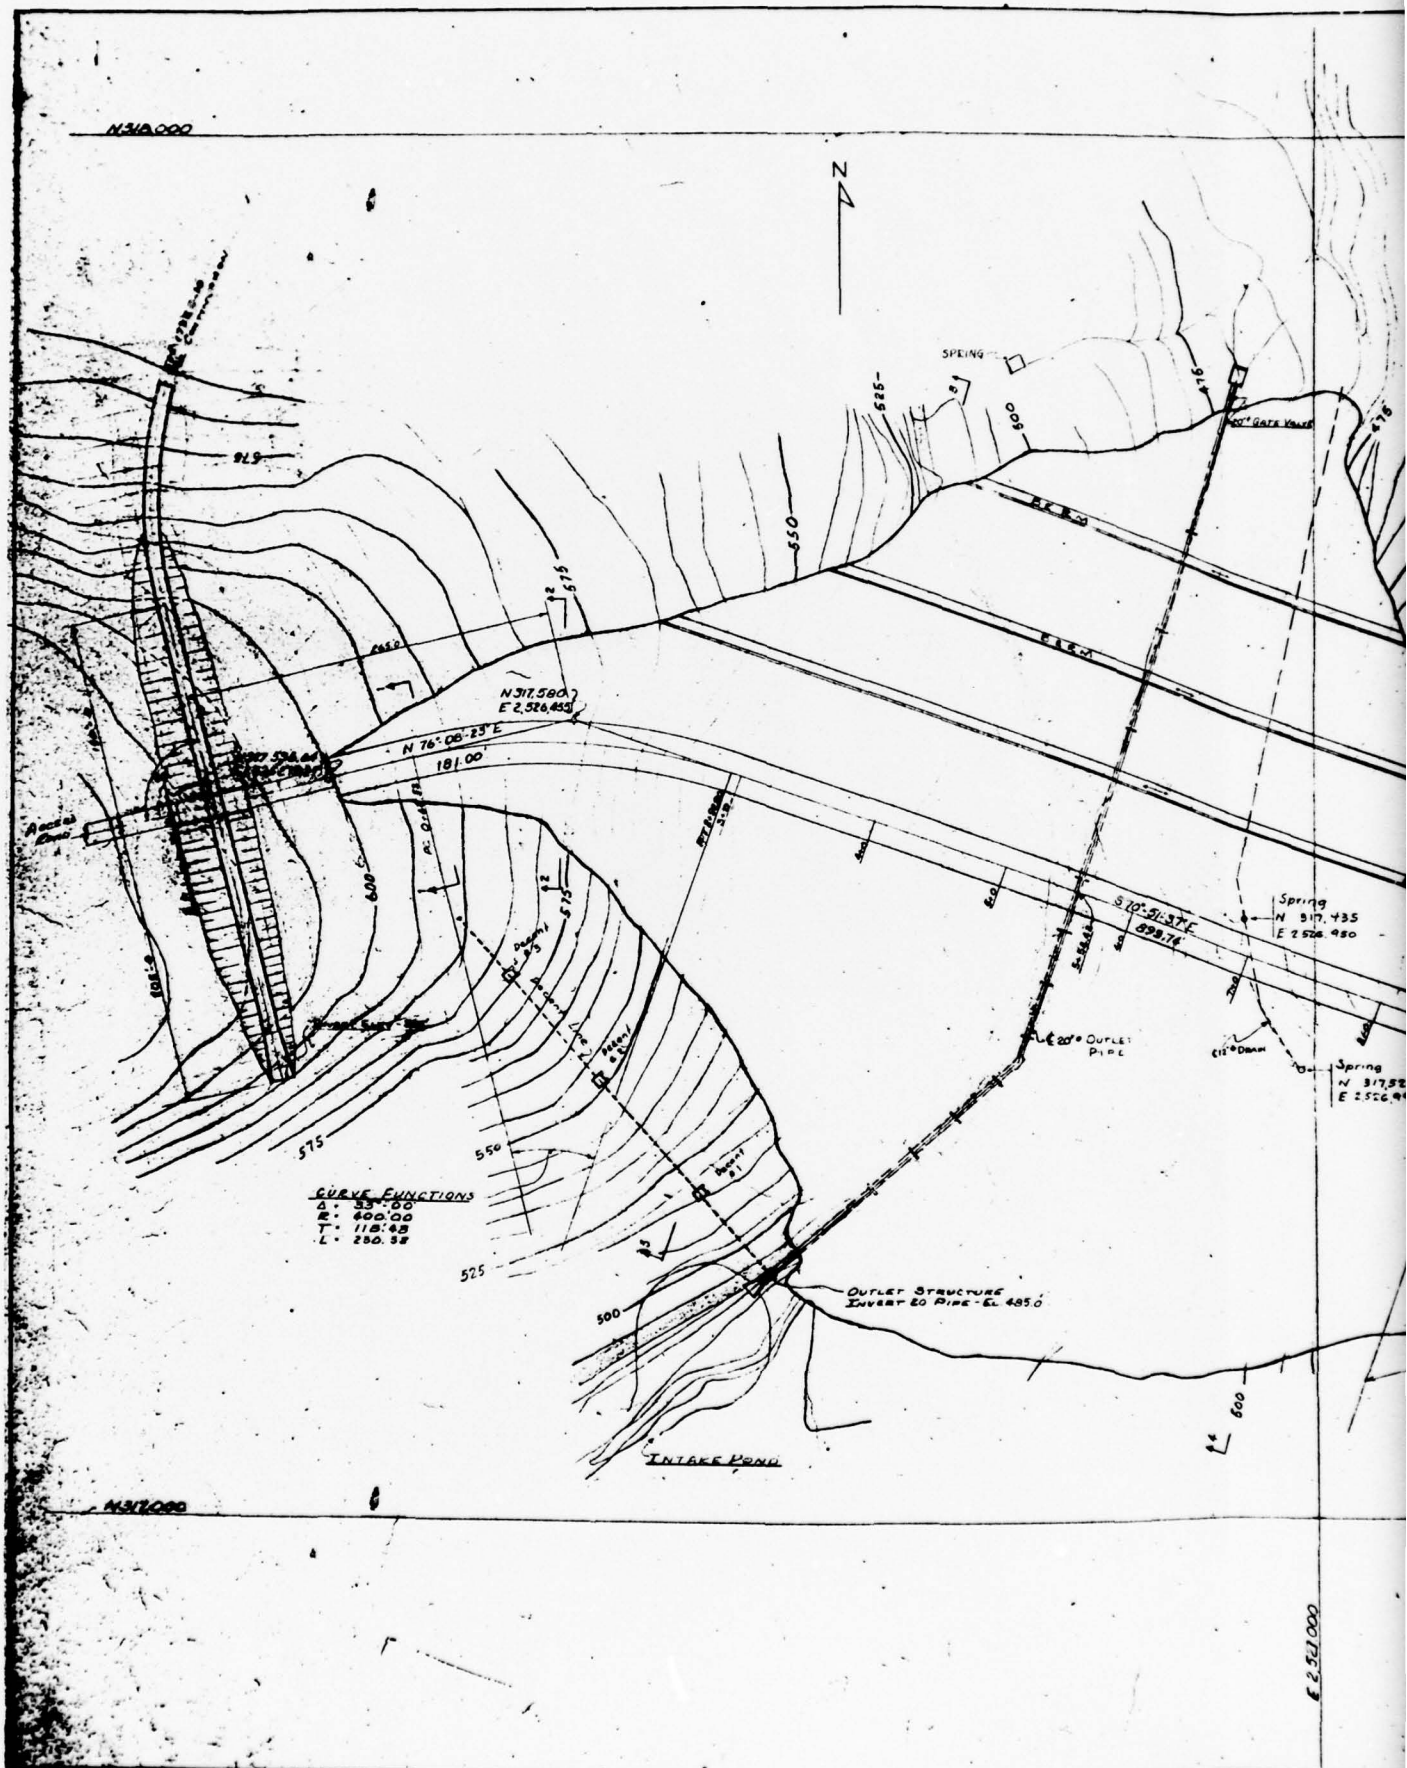
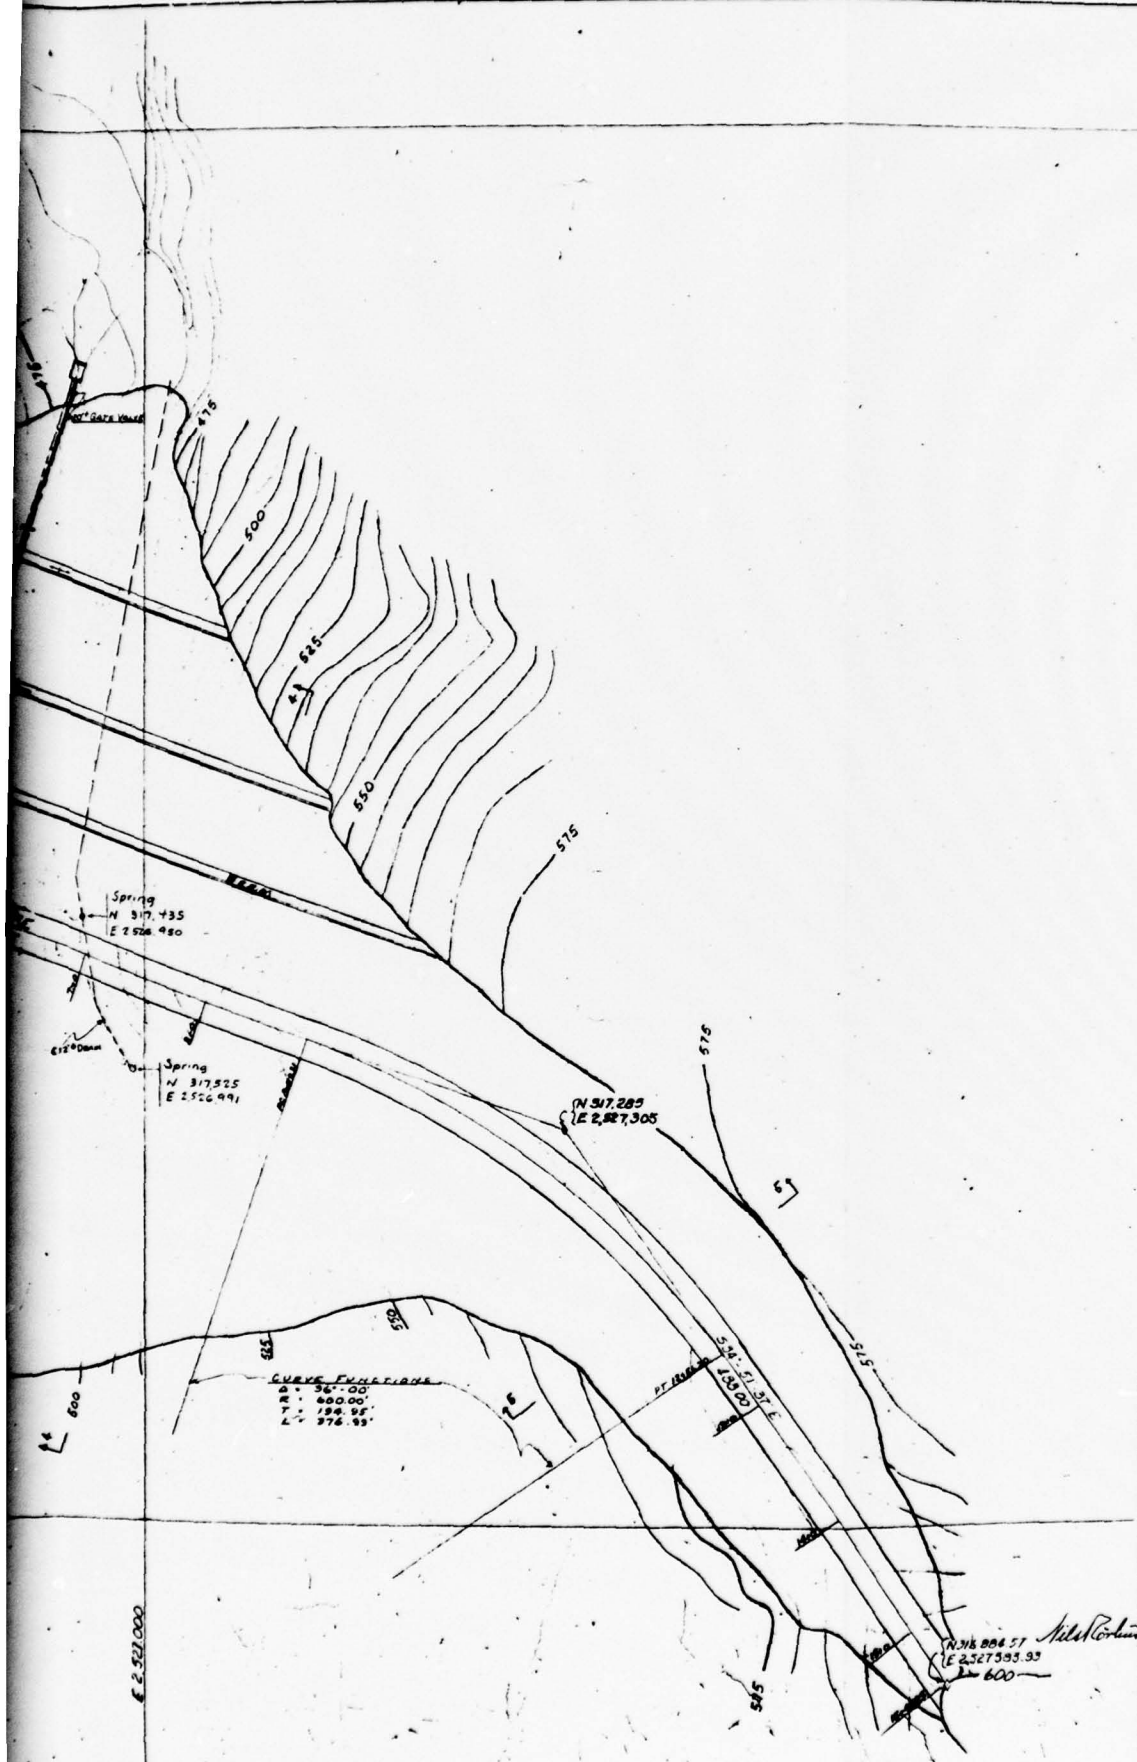
## PLATE 3

The outlet works consist of a series of reinforced concrete decants connected by a 20-inch diameter steel pipe which leads into another 20-inch diameter steel pipe located beneath the embankment with a 20-inch gate valve at the outlet end (see Plate 3, Appendix E). Each decant is 25 feet high, has three walls, and contains a bell inlet 10 feet above the base of the structure. Inflow stages are controlled by means of stop logs above the bell inlet elevation, which is also the crest elevation of the decant. Five decants are located near the upstream toe stretching from the main inlet structure to the left abutment with crest elevations of 520, 550, 580, 595, and 610. Only one decant is in operation at any time and as the reservoir level rises and each decant becomes submerged, the bell inlet is replaced by a blind flange, the pipe is encased in concrete and the bell inlet is transferred to the next higher decant. The water level has been near the top of the fourth decant since mining operations ceased in 1977. A 20-inch diameter steel pipe directs flow from the operating decant to the main inlet structure. The flow then discharges through another 20-inch diameter steel pipe beneath the embankment into the outlet structure, which leads into the natural stream.
